Aviation Investigation Preliminary Report

Location:	Houston, TX	Accident Number:	DCA24FA017
Date & Time:	October 24, 2023, 15:20 Local	Registration:	N510HM (A1); N269AA (A2)
Aircraft:	TEXTRON AVIATION INC 510 (A1); RAYTHEON AIRCRAFT COMPANY HAWKER 850XP (A2)	Injuries:	4 None (A1); 3 None (A2)
Flight Conducted Under:	Part 91: General aviation - Personal (A1); Part 135: Air taxi & commuter - Non-scheduled (A2)

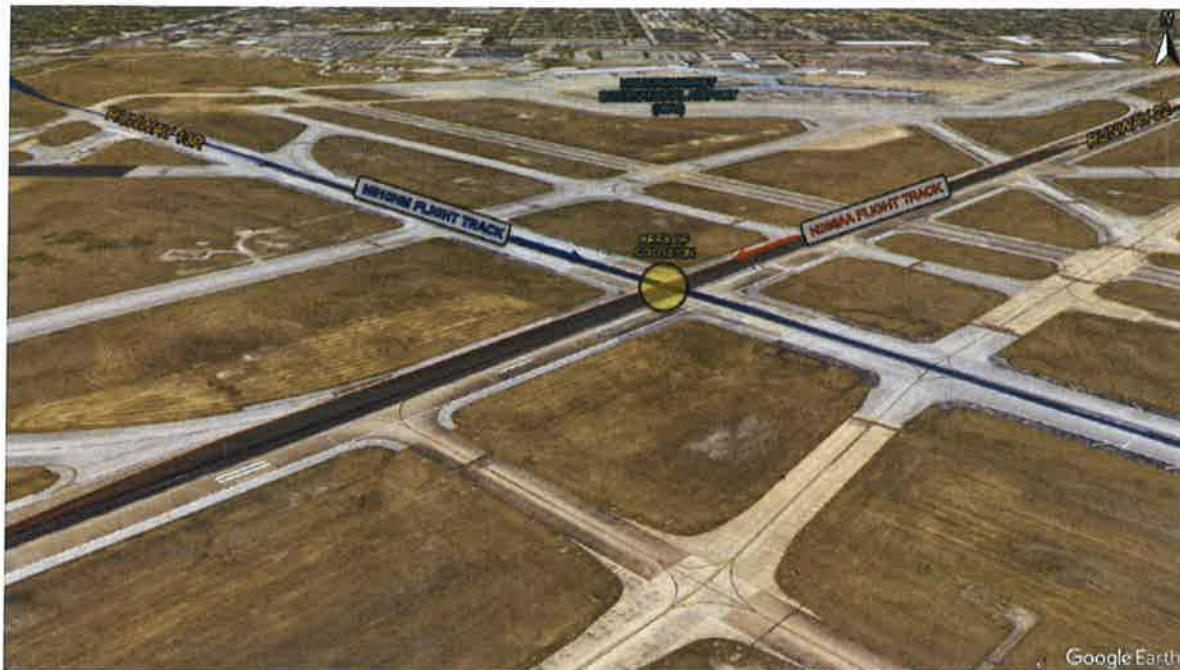
HOU has intersecting runways, and the local controller had instructed the crew of N269AA to line up and wait (LUAW) on runway 22. The crew of N269AA said in a post-accident interview that they believed they heard that they were cleared for takeoff when they took off. The collision between the two airplanes occurred at the intersection of the two runways, see figure 1.

Figure 1. View of both airplanes flight tracks with the area the ground collision occurred highlighted in yellow. The blue line represents N510HM, and the red line represents N269AA.

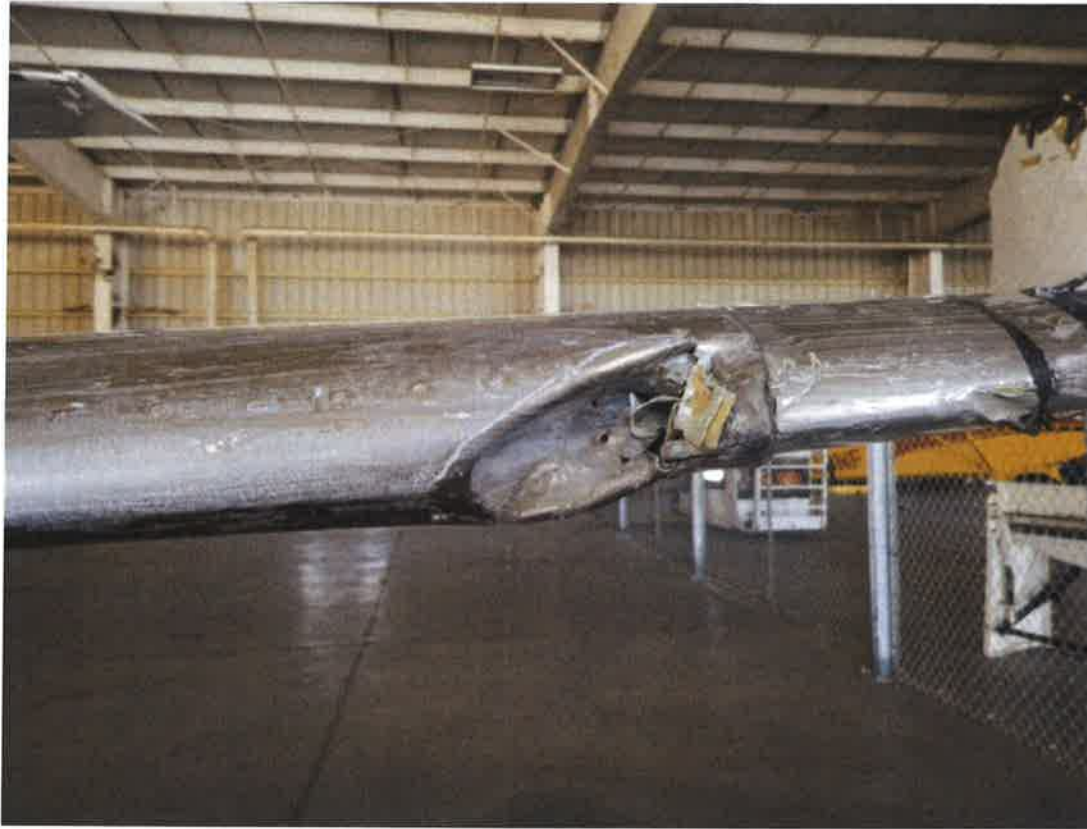
Post-accident examination of N269AA revealed that the left wing exhibited impact damage. The titanium leading-edge panel exhibited a "V-shape" aft indentation to the wing front spar with sheet metal remnants of the Cessna Mustang embedded, see figure 2.

Figure 2. Close up view of N269AA's left-wing leading-edge damage.

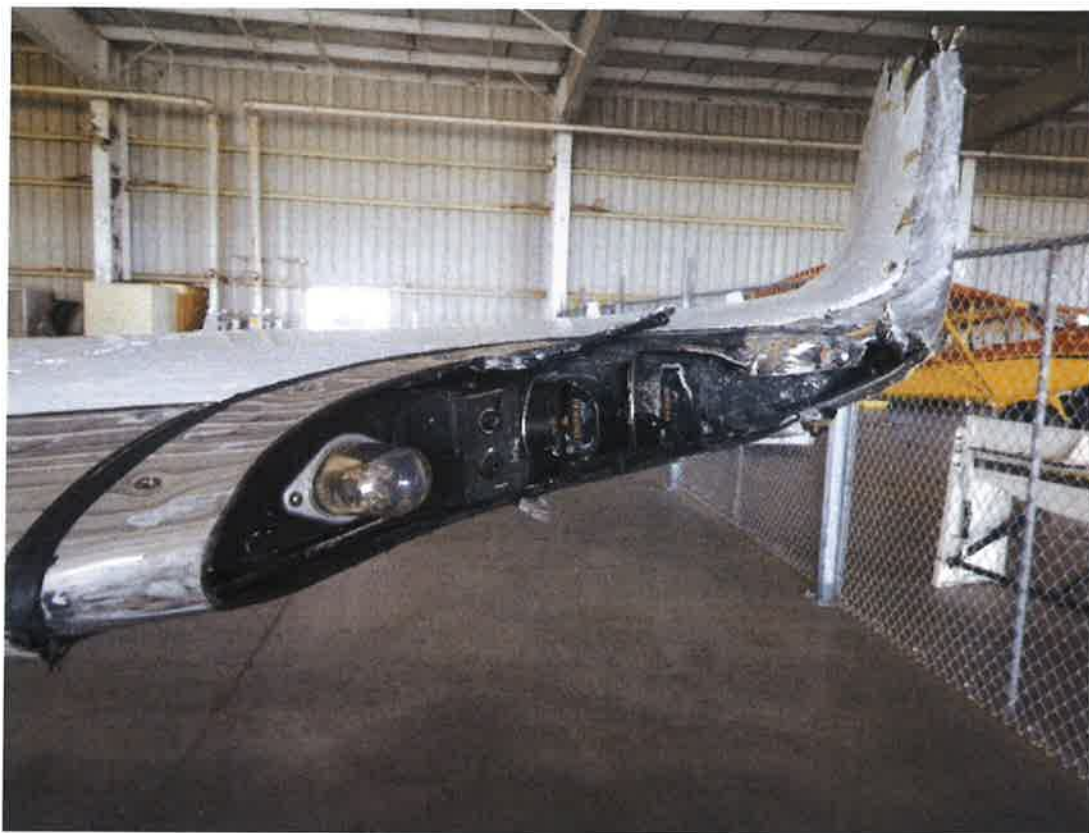
N269AA's left-wing winglet remained attached to the left wing. The winglet leading edge exhibited white paint transfer marks and the navigation light lens was impact separated and pieces of the glass were found in the Cessna Mustang's tail cone/stinger. About ten inches of

the top section of N269AA's winglet had separated due to the impact with N510HM, see figure 3.

Figure 3. Close up view of N269AA's left winglet/navigation light assembly damage.

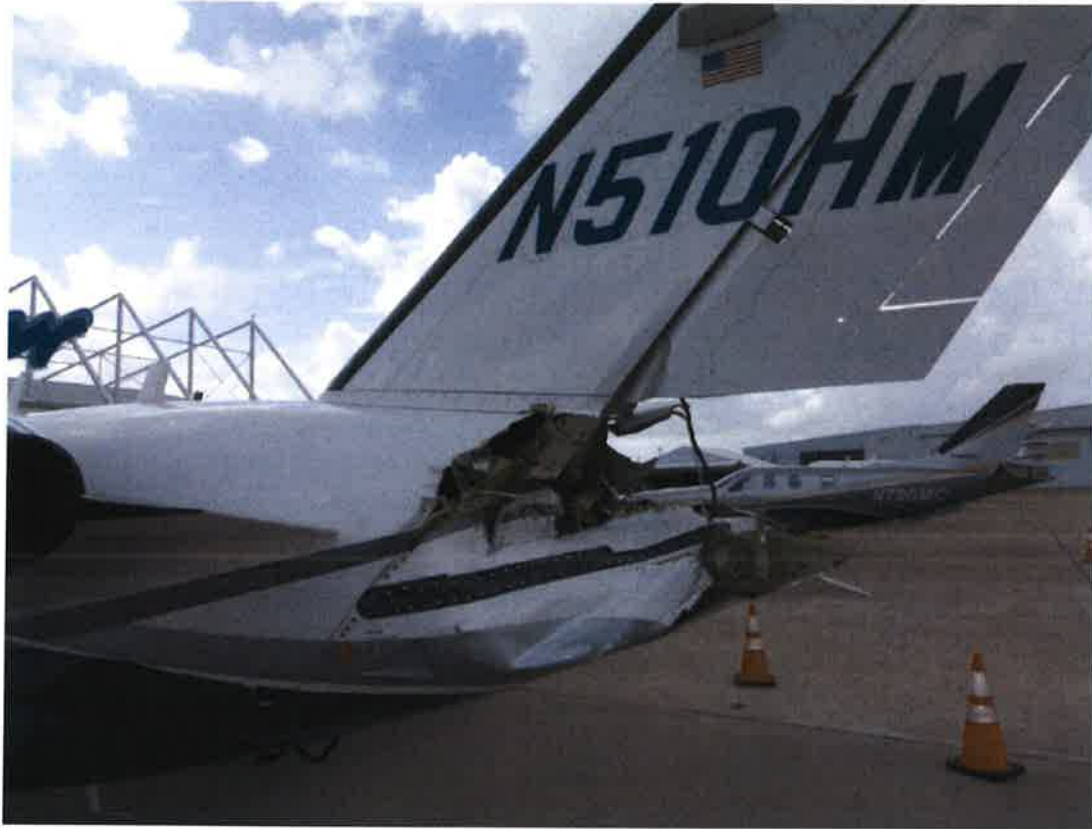
Post-crash examination of N510HM revealed that the left side of its tail section had been impacted by the left wing of N269AA. The torn skin on the tail section was consistent with N269AA's wing penetrating the left side of N510HM's tail stinger and exiting the right side, severing a portion of the stinger. The impact damage was isolated to the area of the empennage, see figures 4, 5 and 6.

The impact fractured and separated a section of the aft canted bulkhead. A section of the aft horizontal stabilizer spar, common to the rudder sector attach point, was torn and bent consistent with the wing impact. The rudder sector mount was torn from the structure at the fastener locations.

The rudder torque tube was fracture separated from the rudder control sector and the rudder. The upper and lower left and lower right rudder control cables were broken in a manner consistent with tensile overload. The upper right rudder control cable remained intact, but the ball end was pulled from the rudder sector. The autopilot rudder servo control cable was fractured in tensile overload. The left autopilot cable pulley bracket, with pulley attached, was separated from the canted bulkhead. The left strake was impact fractured from the tail cone stinger and was recovered from the runway along with various sheet metal fragments from the stinger.

Figure 4. Left side view of N510HM's damage to its empennage.

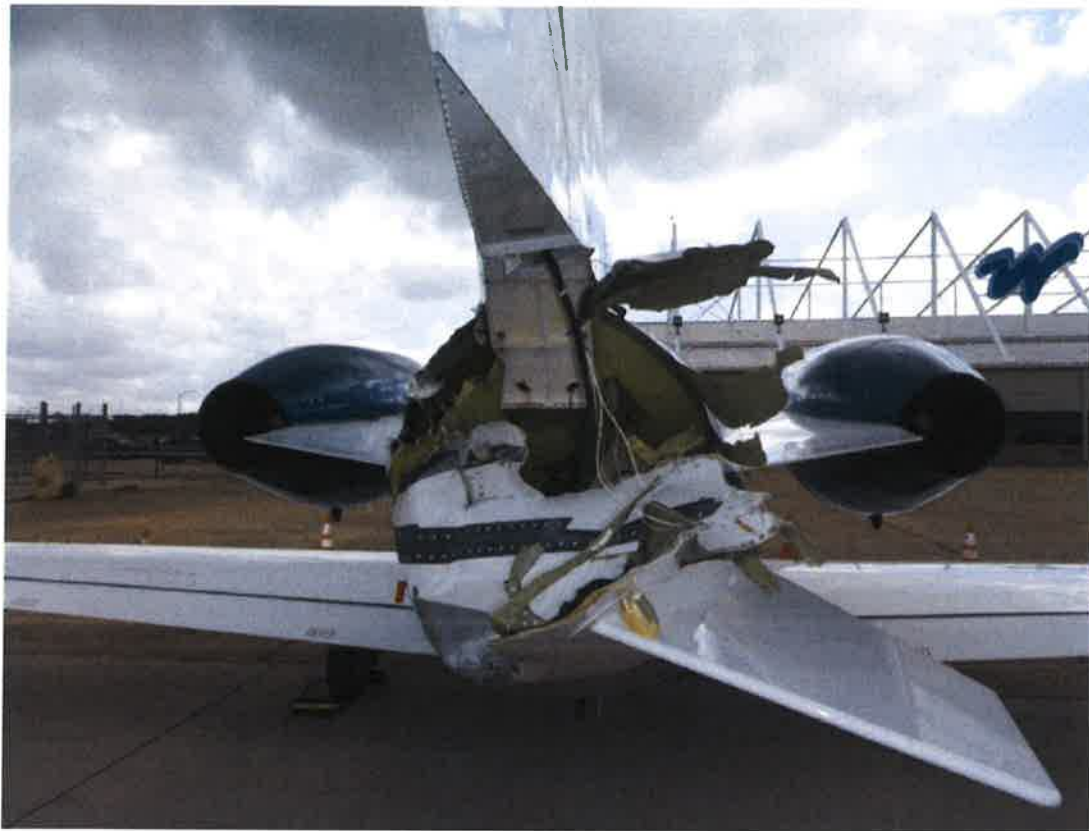
Figure 5. Aft view of N510HM's damage to its empennage.

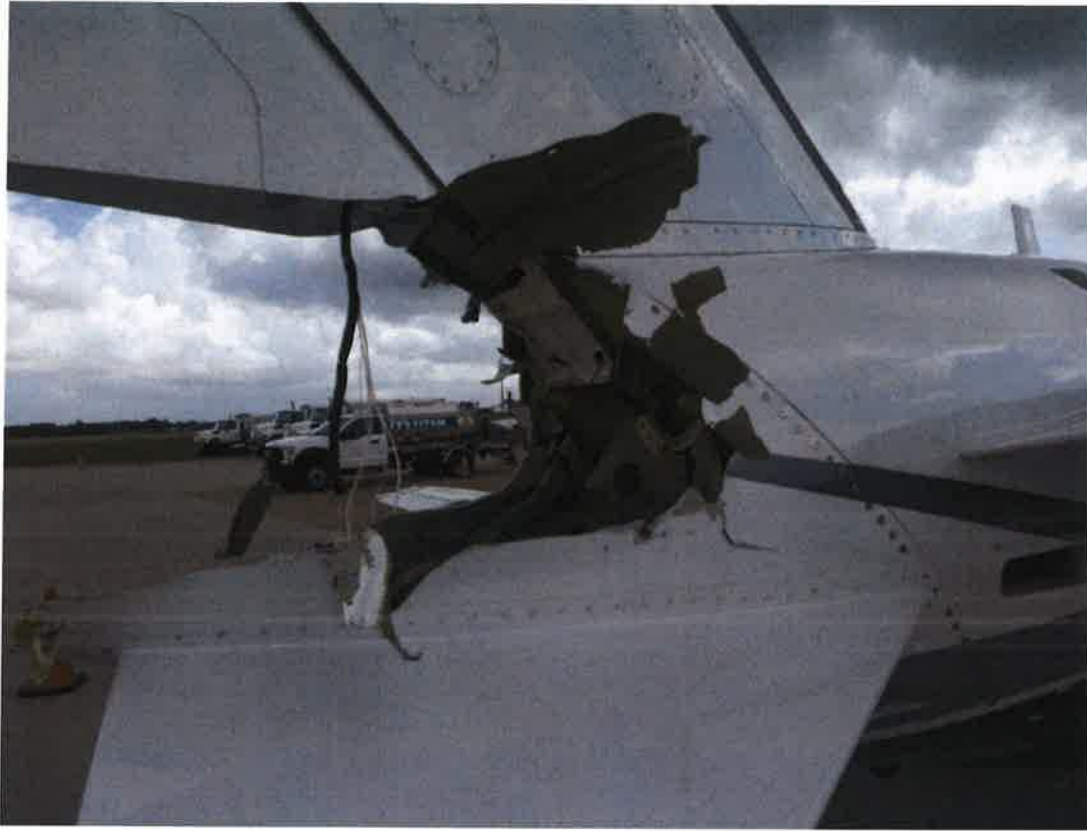
Figure 6. Right side view of N510HM's damage to its empennage.
